DALIC selective plating job on a cruise ship for a French shipyard

Friday, September 10, 2021 – We were contacted by a shipyard in the South of France. It encountered grooves on a propeller shaft of a cruise ship named "Island Princess" under the Bermuda flag.

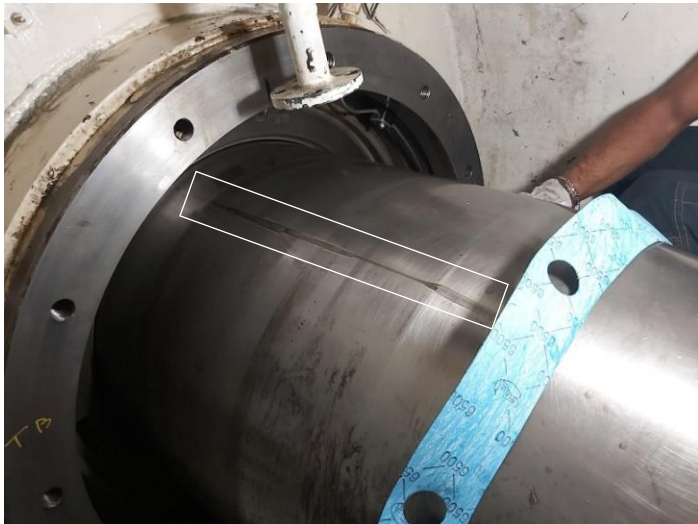
This defect causes mechanical damage and requires repair as soon as possible. Indeed, this anomaly blocks the shipyard and therefore the maintenance of other boats. The shaft is difficult to remove, on-site intervention is necessary.

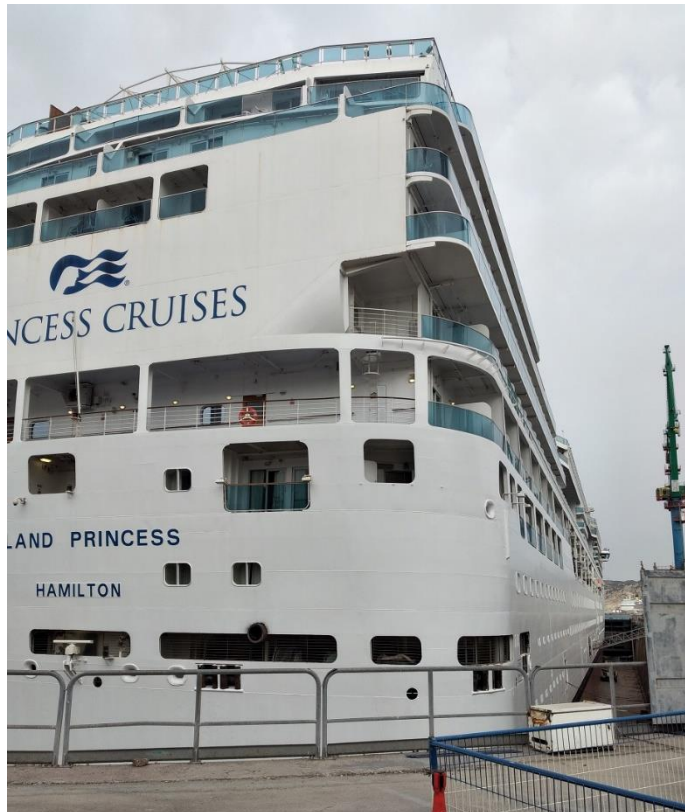
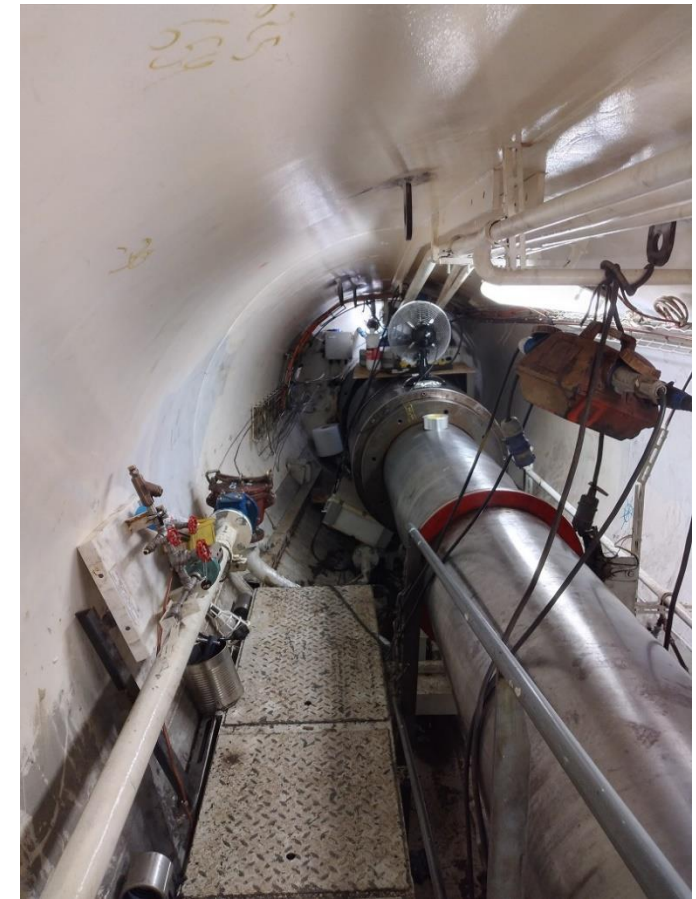
The repair should be carried out in a confined place that is difficult to access (picture above).

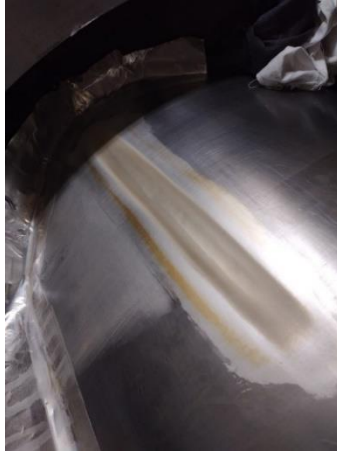
Preliminary stage

Selective plating requires several steps before the final deposit (flaring of the defect, degreasing, activation, undercoat to make the final coating adhesive).

The masking step (adhesive tape around the plating area) is also important to delimit the treatment area and allow the collection of the chemical solutions in a container. The chemical waste is taken care of by the DALIC technician after the work.

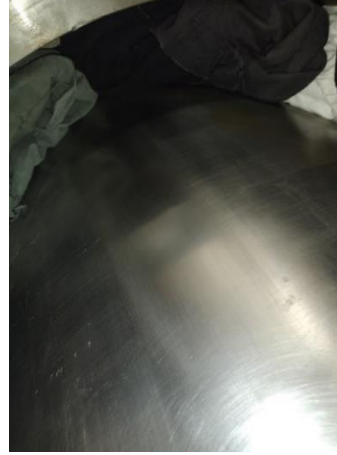
Final aspect

For this repair, we opted for an electrochemical silver plating with a nickel finishing layer.

Manual adjustment is necessary following deposition to restore the original diameter.

- Main coating: Silver S (reference: 13009)
- Tolerance needed: +/- 10 µm
- Silver properties: used for impact filling, electrical conductivity, and corrosion protection
- Finishing stage: Nickel (5 à 10 µm) to increase hardness (440 HV) and to improve aspect
- Manual sanding with scotch brite to restore the dimensions of the initial diameter
- Adhesion tests and thickness measurement
